DEVELOPMENT PROPOSAL FOR PUBLIC COMMENT

Portal Application Number	DA No.	Location	Proposal
PAN- 304413	25/2023	LOT: 144 DP: 1110671, 142 Hilldale Road HILLDALE Applicant: Perception Planning Owners: Mrs A M & Mr R W Alexander Consent Authority: Dungog Shire Council	Dwelling & Retaining wall (Amended Plans)

CIVIL DOCUMENTATION FOR DEVELOPMENT APPLICATION

142 HILLDALE ROAD, HILLDALE, NSW 2420

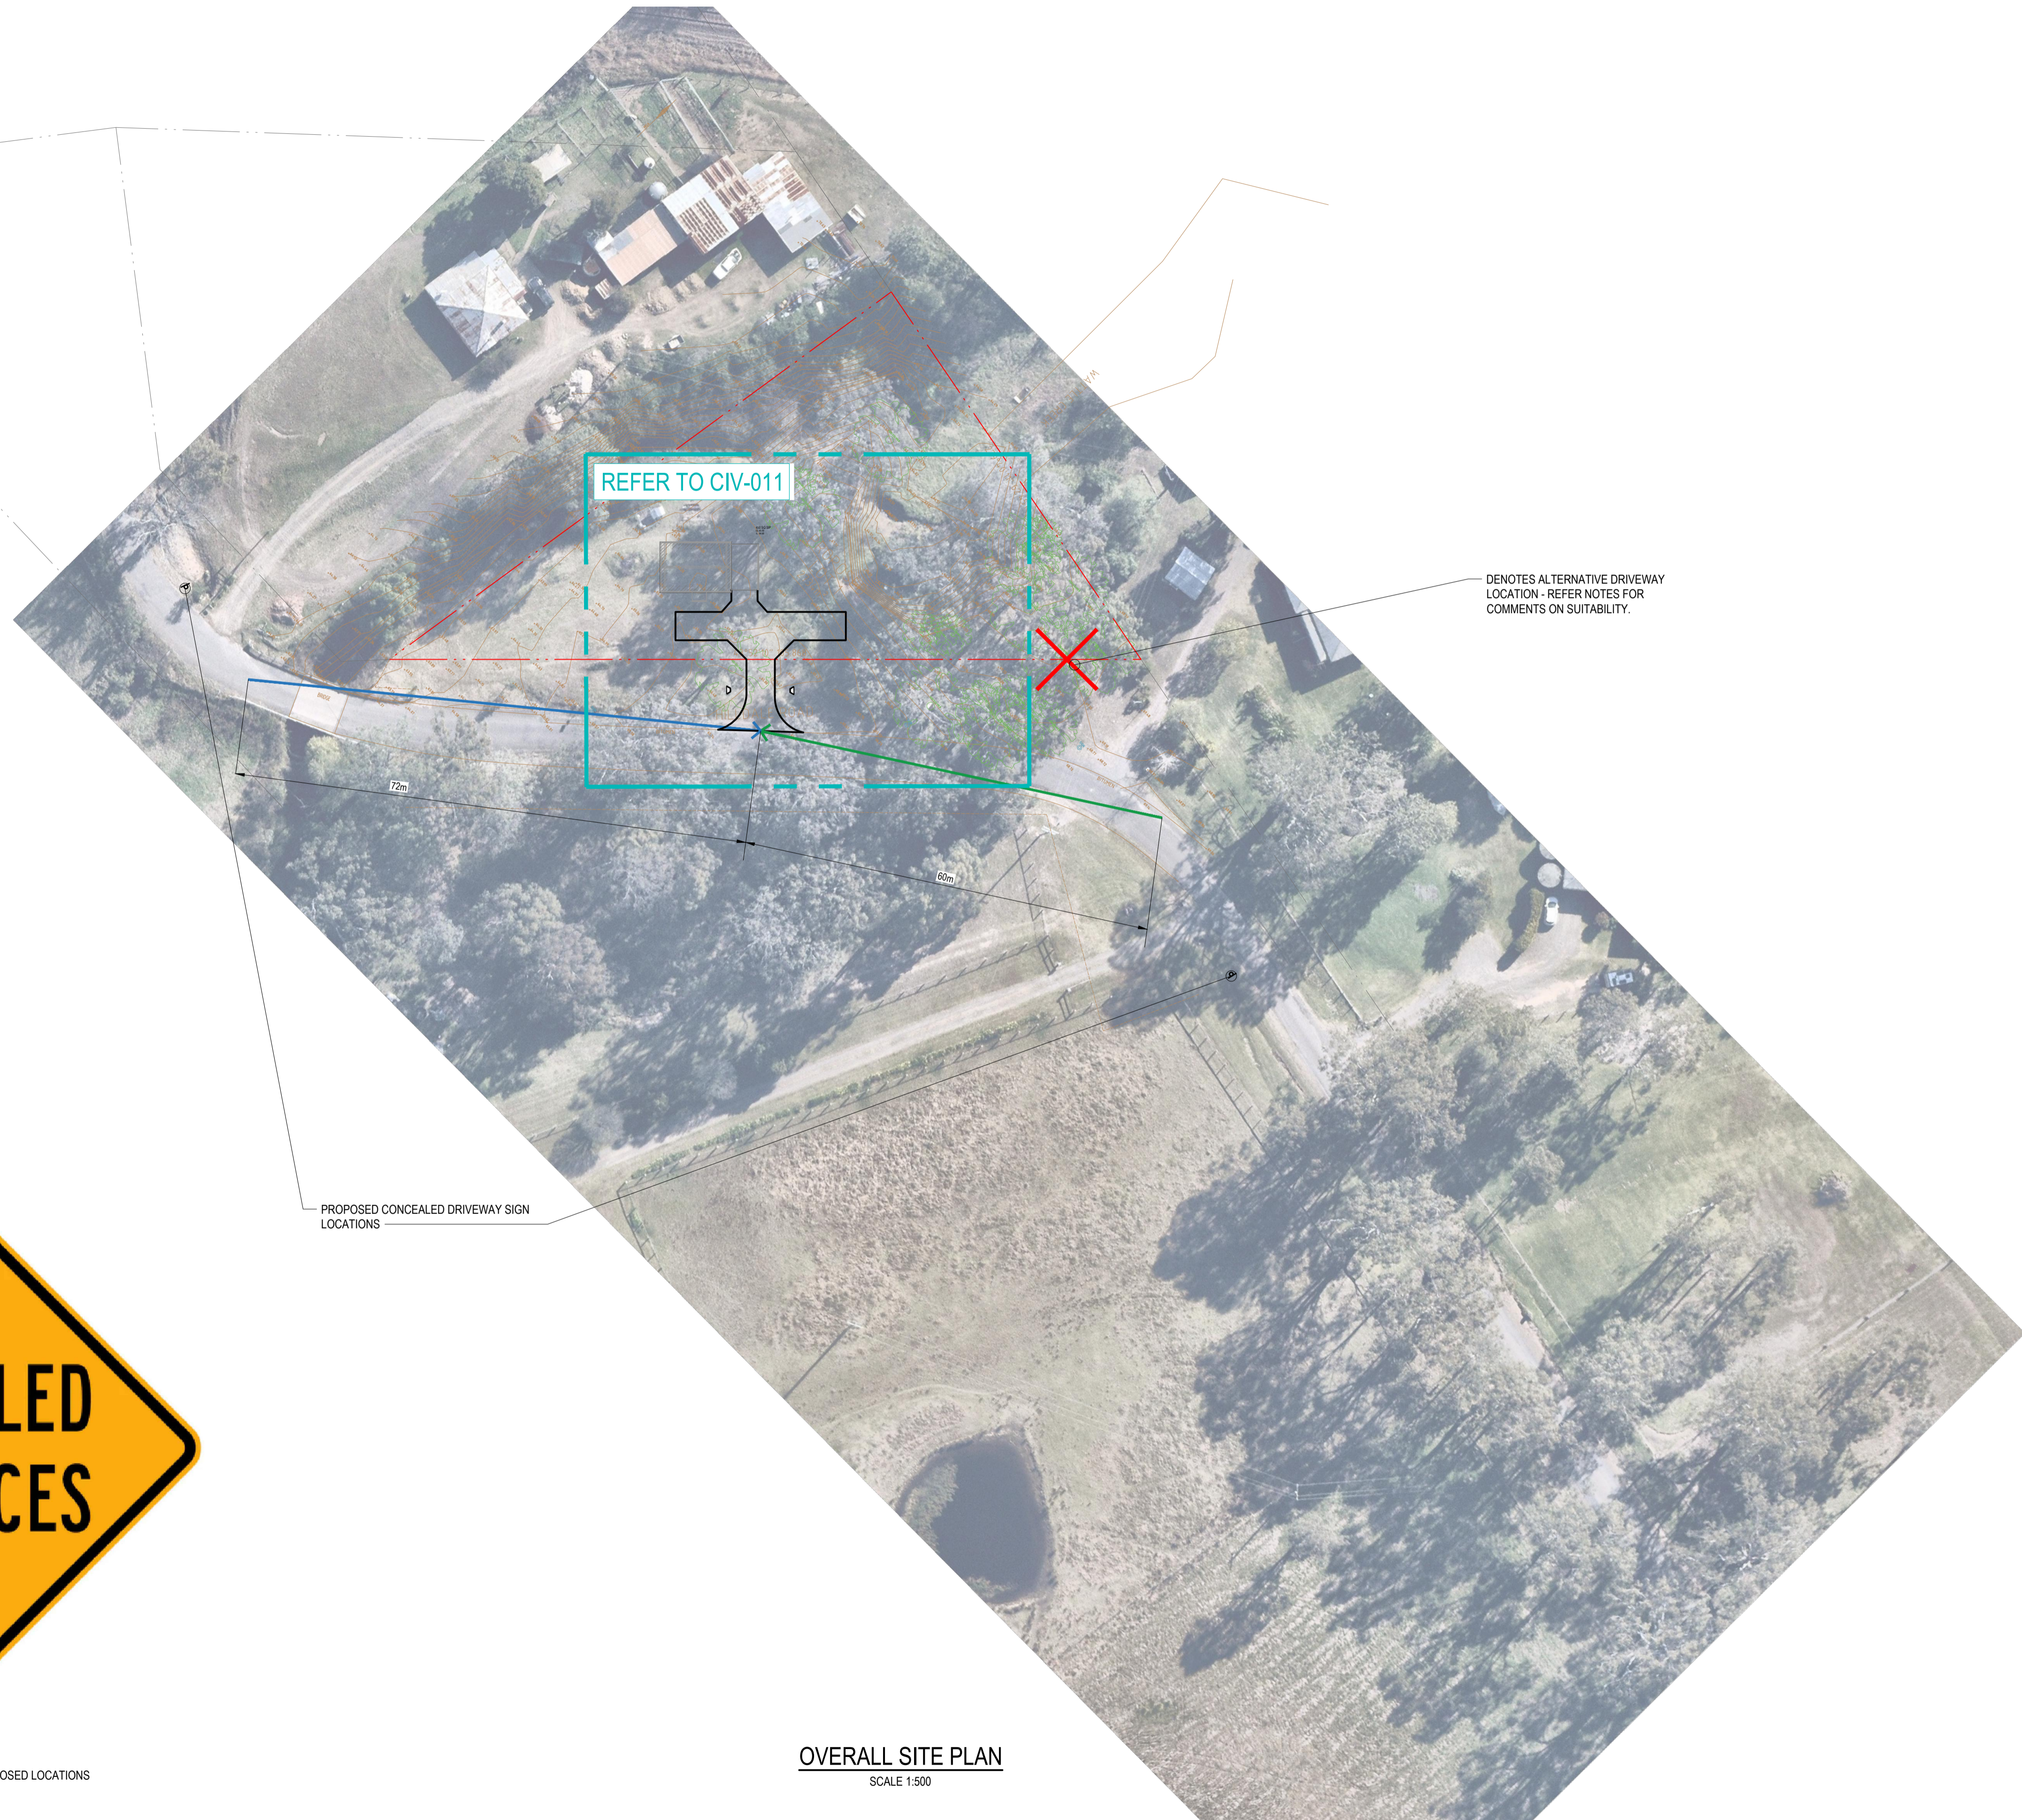
OVERALL SITE PLAN
 SCALE 1:500

THEREFORE THE DRIVEWAY LOCATION SHOWN IS THE MOST APPROPRIATE GIVEN THE EXISTING SITE CONSTRAINTS. THE AVAILABLE SITE DISTANCES IN THIS LOCATION HAVE BEEN SHOWN. IT IS NOTED THAT THESE ARE LESS THAN THOSE REQUIRED BY AS2890.

IT IS PROPOSED THAT CONCEALED DRIVEWAY SIGNS ARE TO BE CONSTRUCTED AS PART OF THE DEVELOPMENT TO MITIGATE THE RISK OF REDUCED DRIVEWAY SITE DISTANCES AS SHOWN.

DENOTES ALTERNATIVE DRIVEWAY LOCATION - REFER NOTES FOR COMMENTS ON SUITABILITY.

PROPOSED CONCEALED DRIVEWAY SIGN LOCATIONS

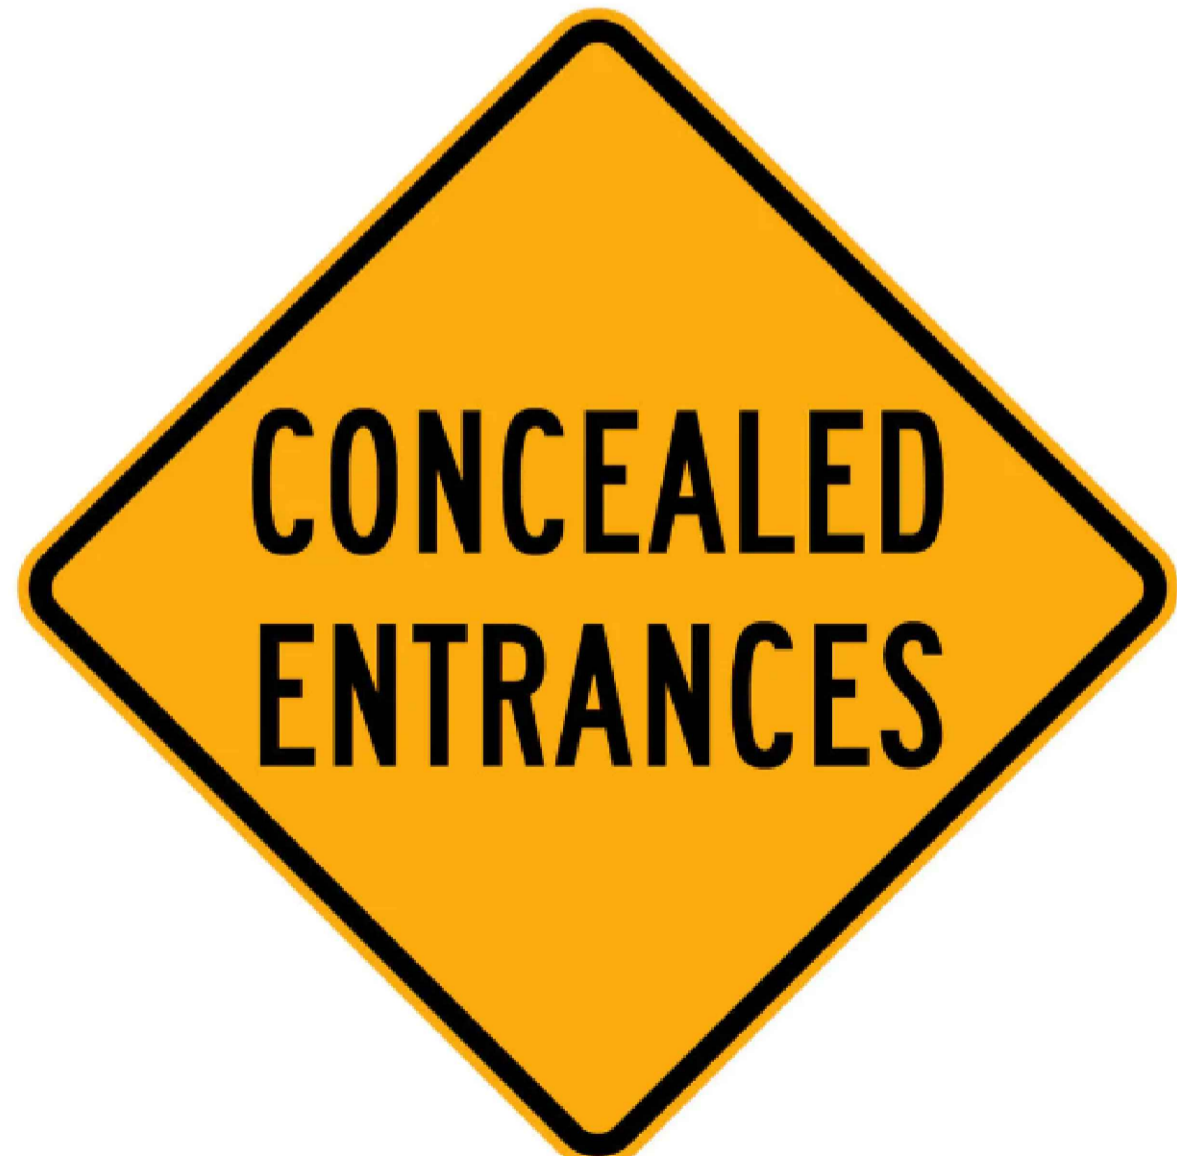
PROPOSED SIGNAGE
 - REFER TO PLAN FOR PROPOSED LOCATIONS

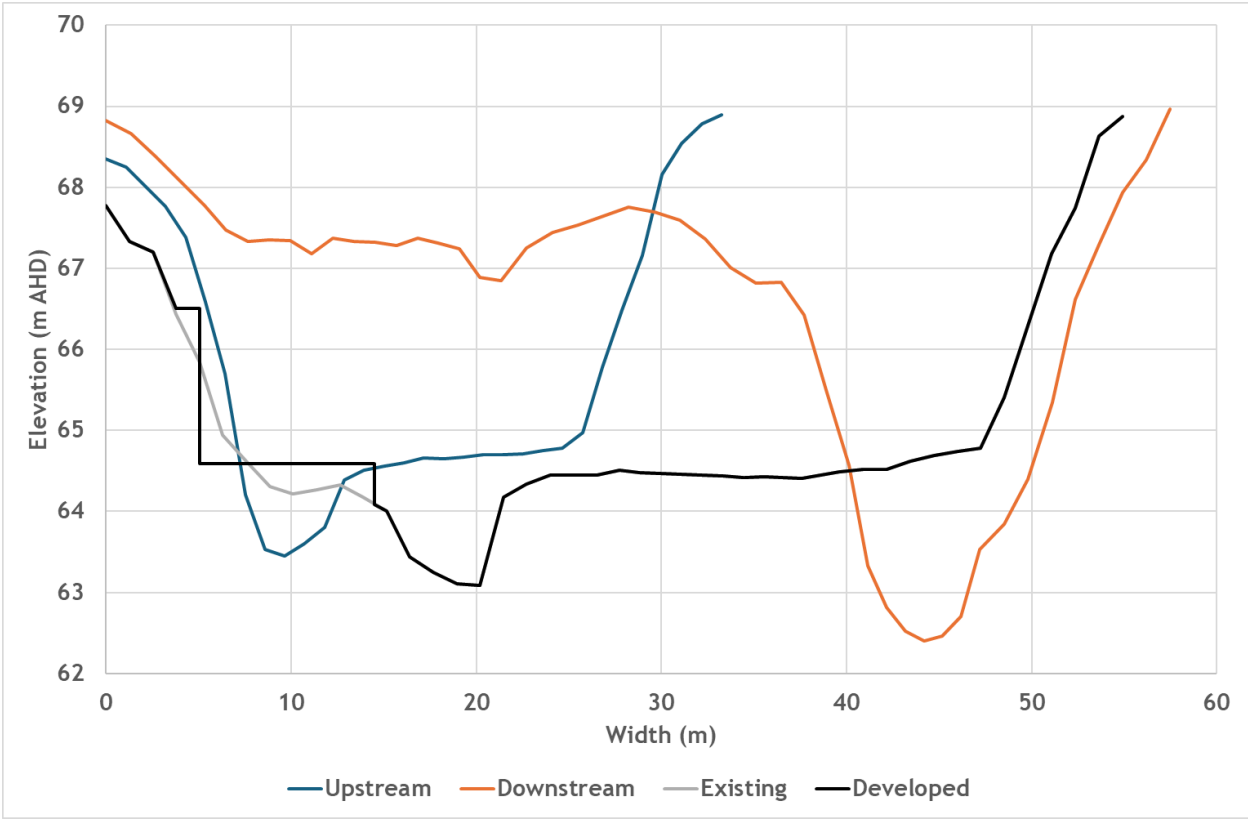
Chart 2 presents a series of channel cross sections in the vicinity of the proposed retaining works. The channel sections 20 m upstream and downstream of the works have much narrower floodplain widths than at the works themselves. In particular, the downstream section has virtually no floodplain, as the channel is constricted through a barrier of higher land. This pinch point acts as the dominant local hydraulic control, limiting conveyance and rendering the location of the proposed works as an area of effective backwater.

Chart 2 – Channel Cross Sections

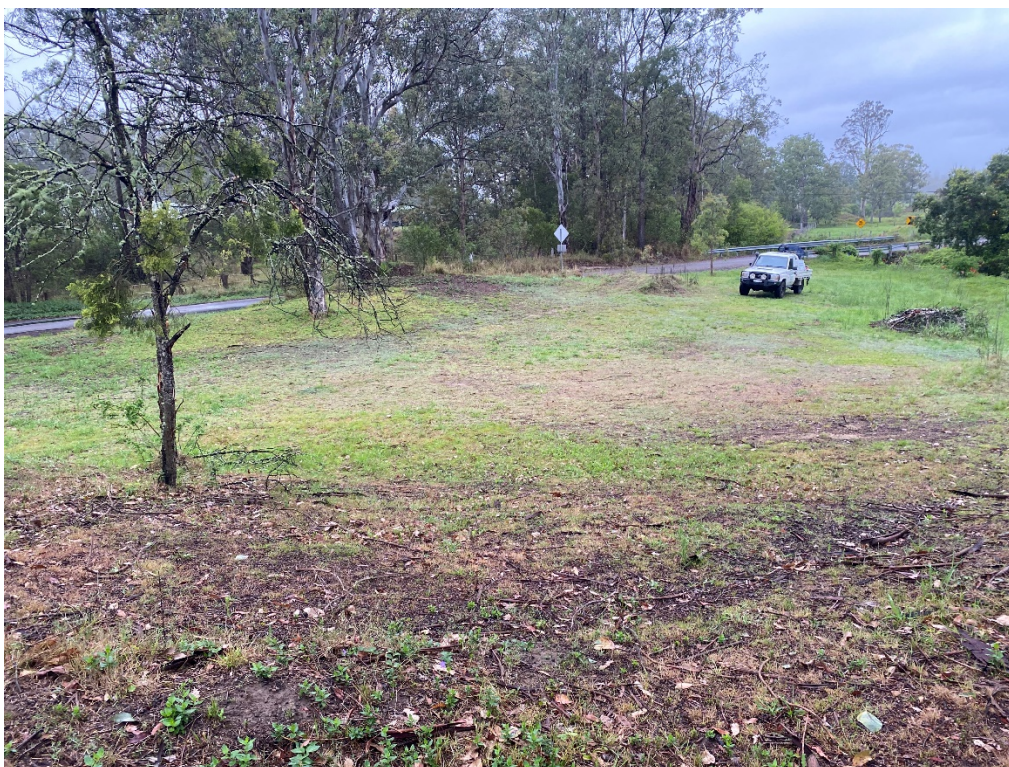
Photograph 1 – Looking south across the proposed building envelope

The location of fieldwork and existing site conditions can be seen in Photographs 1 – 3 below and on the Site Plan within and in the Attachments section of this report.

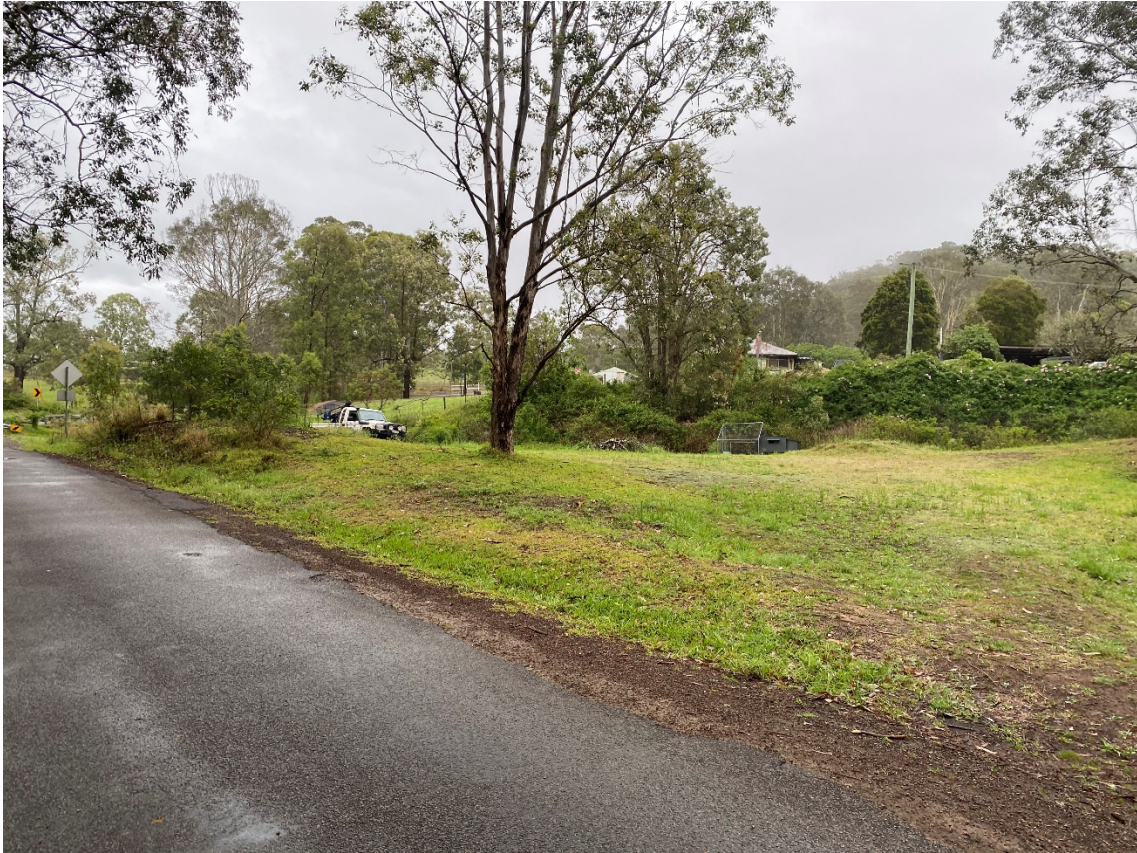
Photograph 2 – Looking west across the proposed building envelope

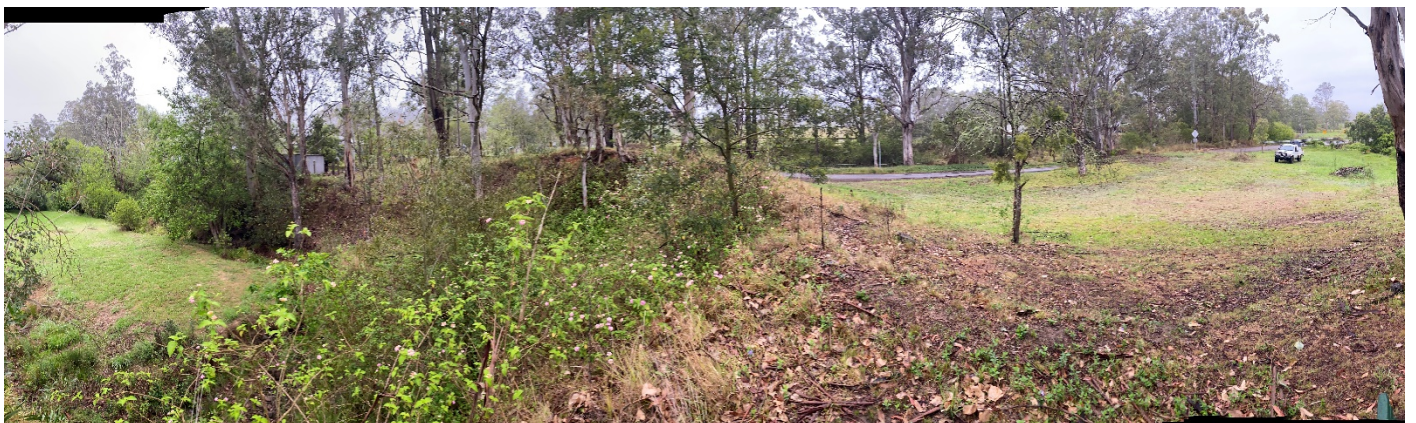
Photograph 3 – Taken from the northern corner of the site looking across the existing creek “washout” area in the foreground and proposed building envelope in the background.

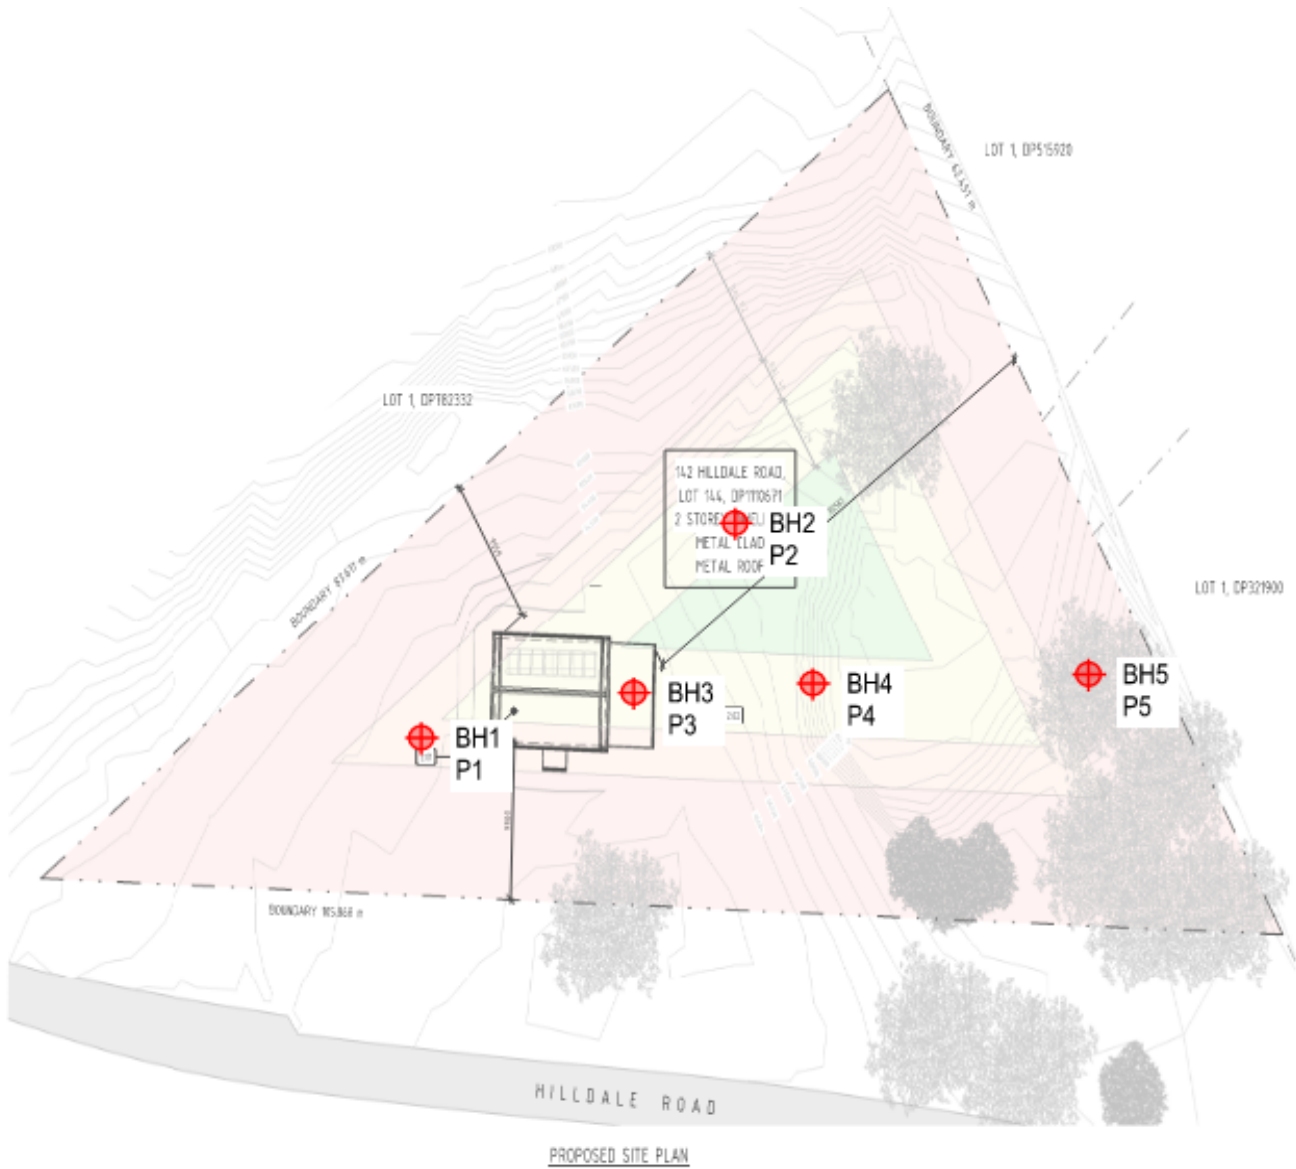
Site Plan

- BH - 100mm CONTINUOUS FLIGHT AUGER
- P - DYNAMIC CONE PENETROMETER

Project Number: 222097
Report Date: 14/12/2023
Fieldwork Date: 24/11/2023
